### The scope

Electrical discharges (ED) in MV power circuits are (1) Partial Discharges (PD) and (2) Partial Arcing (PA). Partial Arcing is a term coined by Martec to explain multiple findings in the field over many years which exhibit some common characteristics of PD.

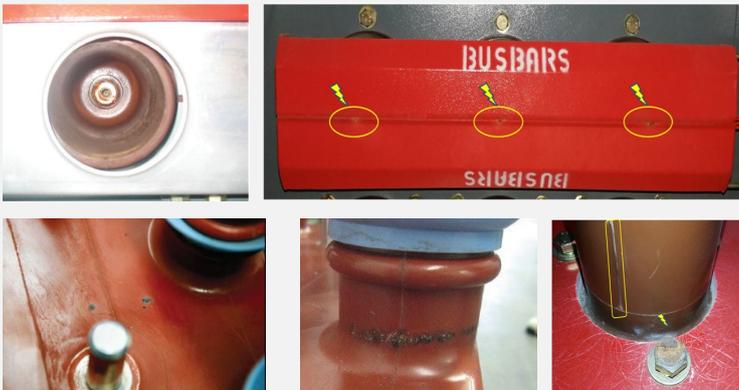
Most of the switchgear breaker problems experienced are associated with partial discharge or partial arcing activity, causing degradation across the surface of bushings.

- Breaker bushings do not align with respective orifice bushings, resulting in an inconsistent electric field around the bushing due to irregular positioning of the shutter box apertures.
- Misaligned shutter boxes may have the same effect as the above.
- Misaligned breakers may also cause the orifice (female) bushing to be damaged, and tracking may occur.
- Misalignment may lead to increased PD action within the cluster.

- Alignment of breakers must be critically looked at.
- Damaged bushings must be replaced.
- Shutter boxes have to be realigned.

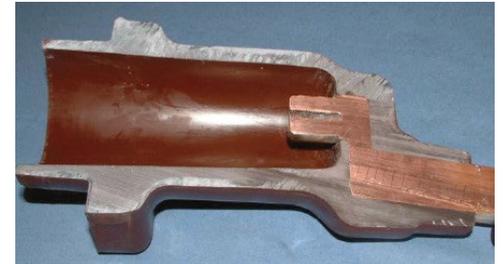
### Female bushing cut open

Note greasy appearance on bushing, this is typical of nitric acid contamination

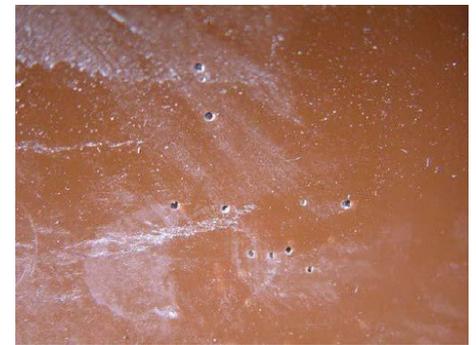
Electrical discharges appearance on bushing.

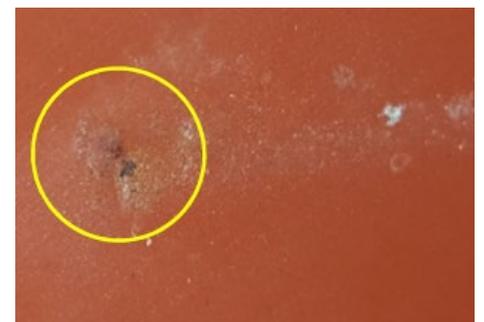
Cracks that can turn into failures.
