### The scope

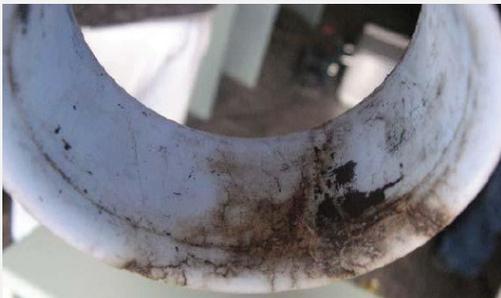
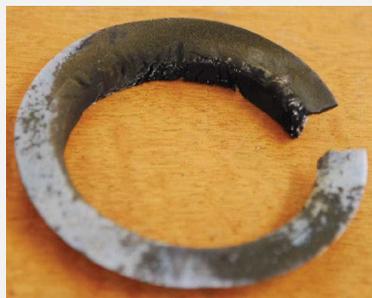
The silicon rubber vermin was trapped inside the female insulator (Sprout) in the blue phase indicated with the yellow arrow in the photograph.

The red arrows are indicating the vermin covers in the correct place on the switchgear.

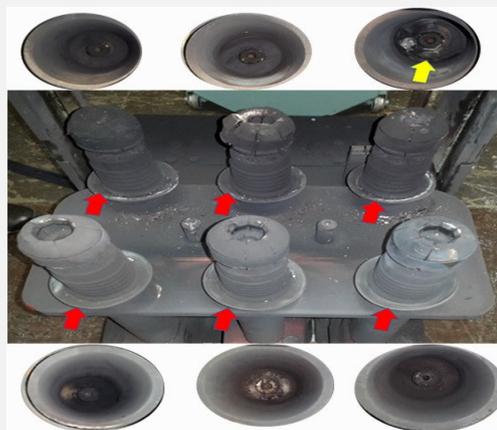
The trapped silicon rubber vermin cover will reduce the space inside the female insulator (sprout). Once the switchgear breaker is racked into position with an extra silicon rubber cover, mechanical stress will add to the switchgear breaker components. The insulation could crack due to the mechanical stress by the extra silicon rubber cover. Refer to the photograph with the crack insulation.

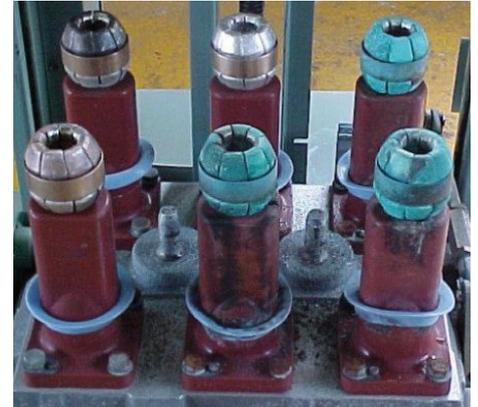
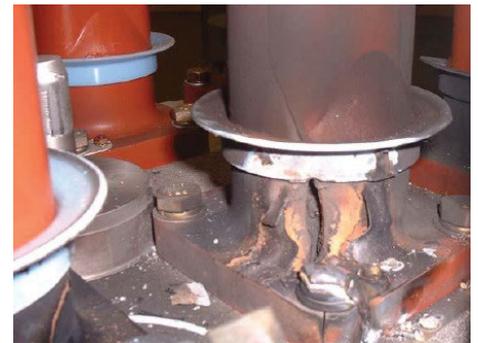
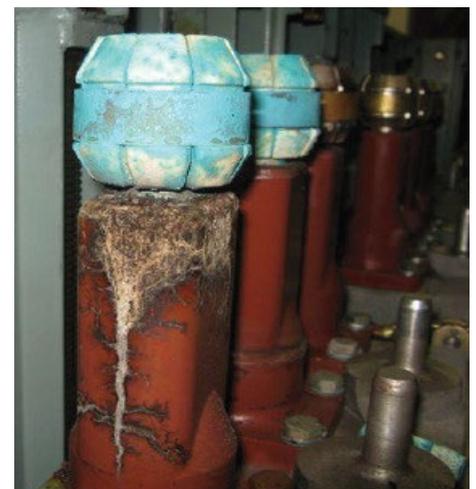
### Partial discharge defects

- Proper adhesion between the silicon vermin guard resin breaker bushing is not achievable. As there are air gaps between the vermin guards and bushings, this will lead to increased PD activity.
- Dirt (surface contamination) is trapped between the poorly adhered vermin seal and them breaker bushing. This leads to increased PD activity in the area of the vermin seal.
- Adverse modification of the electric field in a region of potentially high stress.
