Client Reference

Mining and Minerals | Platinum | Partial Discharge on MV Motors

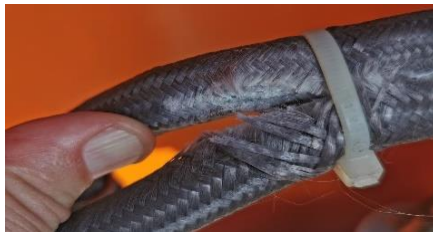
Multiple discharge events were identified, indicating more than one discharge source. Evidence of deterioration was observed from the Zorc leads, as depicted below.

The inspection identified visible deterioration of the Zorc leads, corresponding with the three-phased discharge characteristics observed with the Aquila technology.

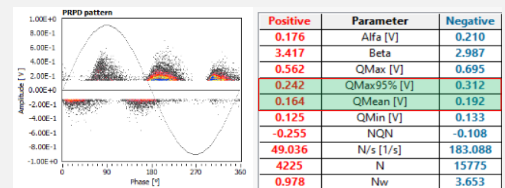
- An online assessment using advanced Aquila technologies.
- TF-map is utilised to filter out noise and place focus on a specific partial discharge event.
- PRPD pattern indicates what type of discharge activity was detected.
- Parameters indicate the severity of the detected activity.
- Based on the findings from the online assessment, these motors were recommended for further investigation.

High PD activity was detected from the motor, the client was notified, and further investigation was carried out using visual inspection.
