# Case Study

## Manufacturing | Afrox Linde | Sasolburg 6.6kV Substation Motor Terminations

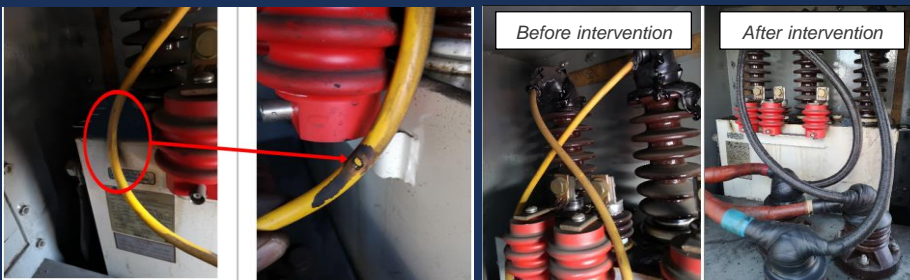
**Over bending of termination leads**, this will create voids under the anti-tracking tube and result to partial discharge and ultimately, a complete failure.

**Water ingress to the terminal boxes.** Termination leads exposed to water while energised are susceptible to a water treeing phenomenon in which tree-like micro voids are formed in the insulation.

Martec conducted a visual inspection of the motor terminations due to the high PD activity detected during the on-line assessment. The inspection revealed deviations from required MV installation standards. Corrective actions were administered by Martec to prevent zorc leads from touching the metal casing. Physical damage and overbending of termination leads could not be rectified during the inspection. It was strongly recommended that the terminations be periodic trended until re-installed under quality assurance processes.
