Introduction Discharges in Type “C” MV Terminations

Compiled by John Sherriff | January 2019 | Rev 1

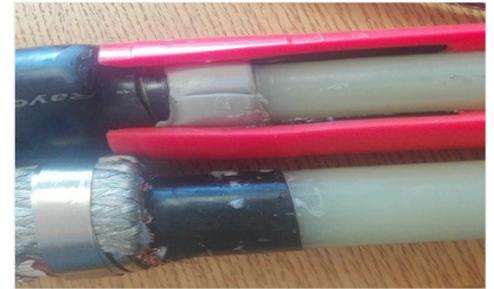
Defects leading to failure

The grey sealant tape was applied to the screen cut and this should not have being installed at this position.

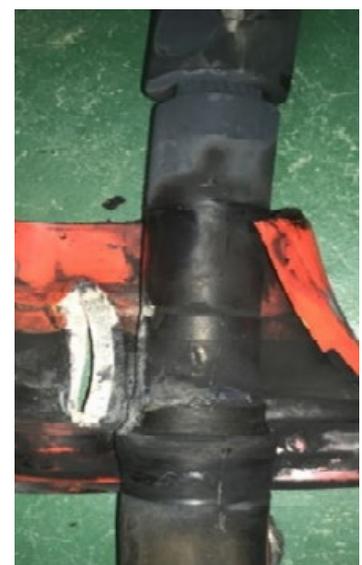
Incorrect installation of the stress control will lead to tracking type discharges and premature failure.

Creepage distance is incorrect that create tracking inside the termination and lead to failure
