# Client Reference

## In-time Monitoring to Ensure Plant Availability and Reliability | 33 kV Switchgear

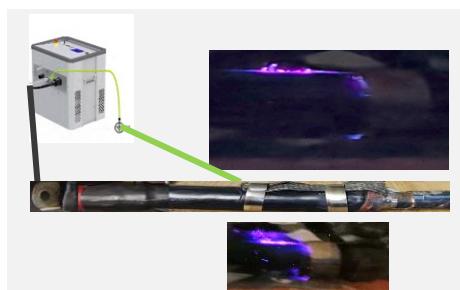
- Our client experienced failure on their electrical smelter.
- Very high electrical partial discharges activity was identified on furnace cable terminations while performing PD diagnostic analysis of the online monitoring data.
- Potential defects were monitored until an emergency shut was arranged for further inspection and investigation.
- We replaced two terminations with the highest discharges. Investigation and tests were conducted on the two terminations to determine the root cause of the discharges.

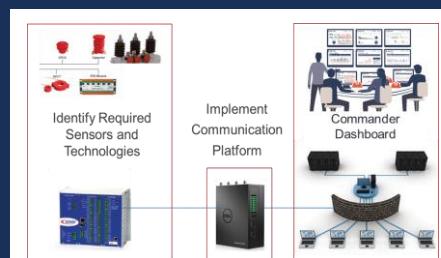
- An in-time PD monitoring system was installed on the 33 kV switchgear to measure electrical partial discharges within the switchgear components.
