Client Reference

Intime Monitoring to Ensure Plant Availability and Reliability | 33 kV Switchgear

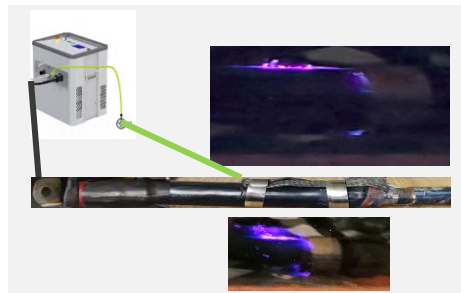
- Our client experienced failure on their electrical smelter.
- Very high electrical partial discharges activity was identified on furnace cable terminations while performing PD diagnostic analysis of the online monitoring data.
- Potential defects were monitored until an emergency shut was arranged for further inspection and investigation.
- We replaced two terminations with the highest discharges. Investigation and tests were conducted on the two terminations to determine the root cause of the discharges.

- An in-time PD monitoring system was installed on the 33 kV switchgear to measure electrical partial discharges within the switchgear components.
