Case Study

Manufacturing | Afrox Linde | Witbank 33/11kV Transformer T-9 on-line assessment

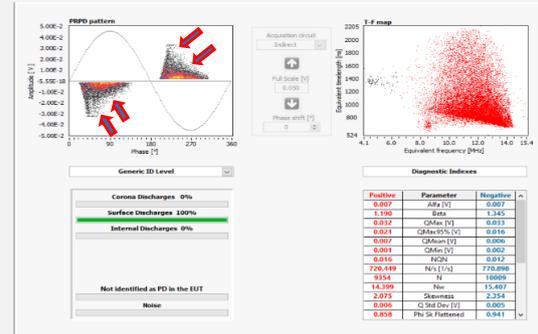
- Martec conducted an on-line assessment using the advanced Aquila and PDFSA technologies.
- The Aquila technology utilises a PD analysis software tool called TF mapping, which allows for effective separation of external noise and detection of PD even at or below noise level.
- Both technologies are able to identify different types of PD phenomena such as internal, surface and corona PD.
- Moderate to high surface PD signals were detected during on-line condition assessment which present a high risk of failure.
