# TechTalk

## Introduction MV Motors Partial Discharges

Compiled by John Sherriff | January 2019 | Rev 1

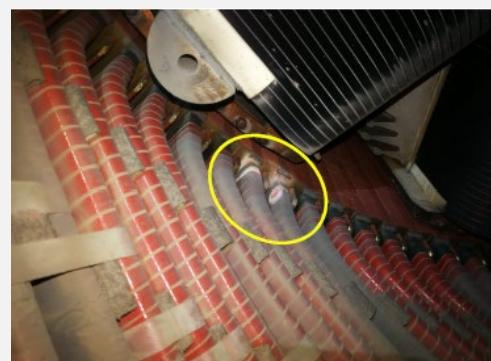
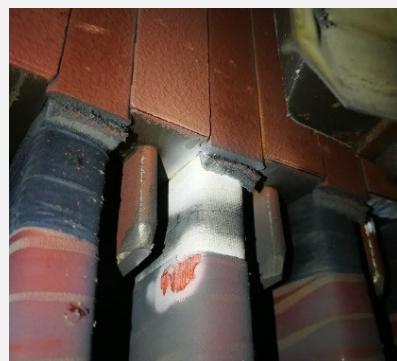
1. Main wall insulation
2. Turn insulation
3. Stress grading
4. Corona shield
5. End-winding sealing tape
6. Bracing material
7. Wedging material

Almost all medium and high voltage motor and generator stator windings rated 6 kV and above have coatings on the surface of the coils or bars to suppress the occurrence of partial discharges (PD) on coils or bars operating at high voltage.

In the stator core slot area of the coil/bar, under the wedges (7) and for a few centimetres outside of it, the coating is usually a graphite-loaded paint or tape that is referred to as the semi-conductive or semi-con coating. It is also called the conductive, outer corona protection or partial discharge suppression coating (Corona Shield 4). The semi-con coating has a surface area resistance of a few hundred to a few thousand ohms per square. This prevents the build-up of any voltage between the surface of the coil and the stator core, and thus prevents surface discharges.

There is a different surface coating that extends from the end of the semi-con coating to about 5 to 20 cm into the end winding area. This coating is often referred to as the stress relief coating (Stress Grading – 3), the end winding corona protection, the semi-conductive coating, or the silicon carbide coating. The purpose of the silicon carbide coating is to linearize the axial electric field at the end of the semi-con coating, which would otherwise be highly non-uniform and thus create PD at the ends of the semi-con coating.
